LH701A-SFP and LH702A-LC

Driver Update

Driver Installation Note - Change "Speed and Duplex" to "100 Mbps Full Duplex"

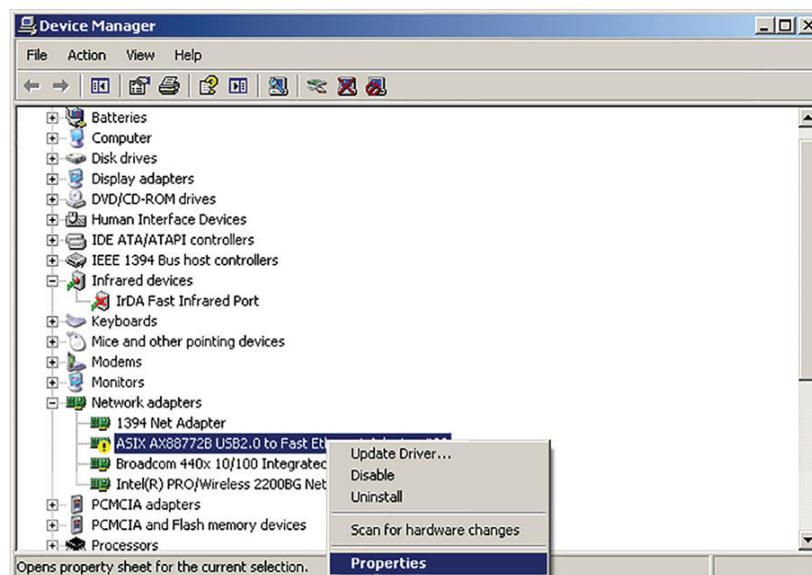
2. Select and right click the "ASIX AX88772B USB to Fast Ethernet Adapter" (the name of the chipset / manufacturer). The General tab displays the message "Windows has stopped this device because it has reported problems. (Code 43)".
3. Select "Properties" and then select the "Advanced" tab.

1. In Windows, navigate to the Start > Settings > Control Panel > System > Device Manager > Network Adapters menu path.

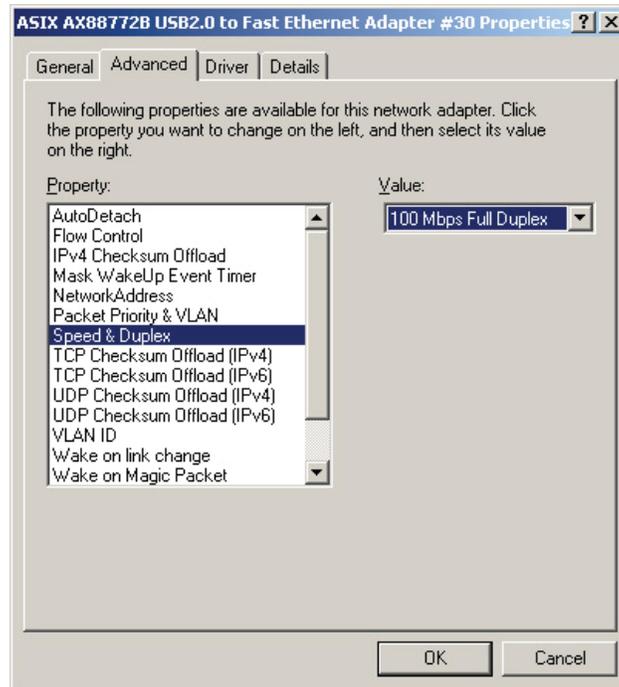
After you successfully install the driver, the LH701A-SFP or LH702A-LC will work properly for a short time. To ensure continual operation, you must change the "Speed and Duplex Property Value" as described below.

4. At the "Speed and Duplex Property Value" dropdown, change the Ethernet link speed from "Auto Negotiation" to "100 Mbps Full Duplex."
5. Click the OK button.
6. Unplug and replug the LH701A-SFP or LH702A-LC. The device will now run properly.
